Pearson Creek Stream Restoration Plan

May 2012

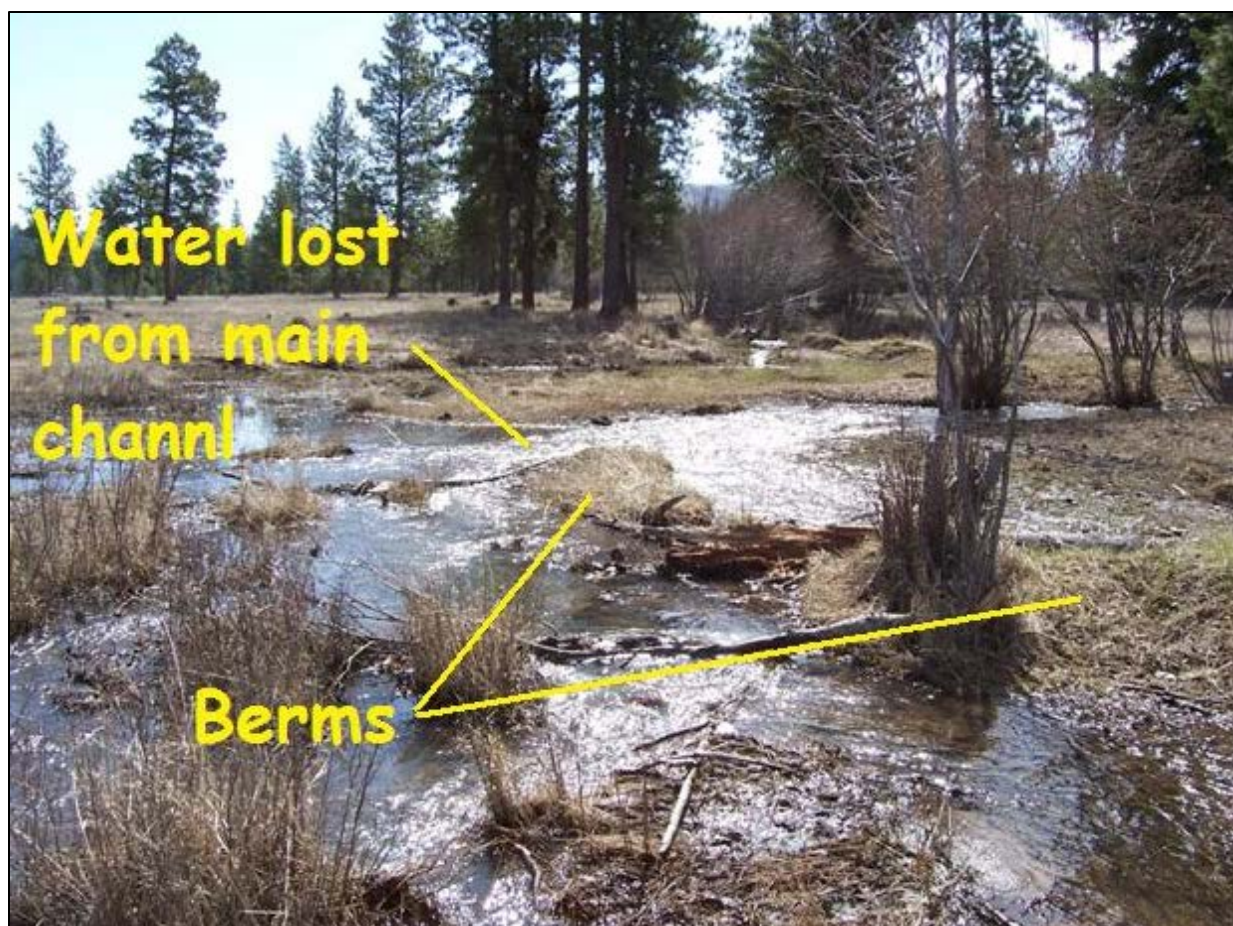
Photo 1: This photo shows a section of Pearson Creek where channelization and berms have perched Pearson Creek above its original channel elevation. Notice the loss of water from holes in the berm.

elevation of the original Pearson Creek channel (Figure 2). To maintain flows at this perched elevation, Pearson Creek has been bermed throughout the channelized reach (Photo 1). The bermed channel drains into a wetland with no defined channel before returning back to Pearson Creek through an undersized culvert. Upstream of the wetland, the bermed channel also loses about 50% of high flows through holes in the berm. This water flows overland before returning to Pearson Creek through a ditch and then entering the undersized culvert. This loss of water occurs during the cutthroat trout migration period and appears to result in the loss of migrant westslope cutthroat trout from the stream (Photo 2). Montana Fish, Wildlife and Parks biologists have measured velocities through the culvert at > 6 feet-per-second during the cutthroat trout migration period. These velocities are high enough to prevent the upstream movement of migratory fish from ascending the stream into upstream spawning areas during certain flow events.

In order to meet restoration objectives, four project elements have been identified. These include 1) reconstruction of 1,286 lineal feet of new channel where the stream is currently channelized, perched and bermed above the valley floor (Photo 1), 2) replacement of the undersized culvert to restore aquatic organism passage at all ranges of flow and correct improper road drainage conditions (photo 5), 3) riparian revegetation using native woody plants, and 4) grazing management changes that include riparian fencing to protect and improve cutthroat trout habitat.

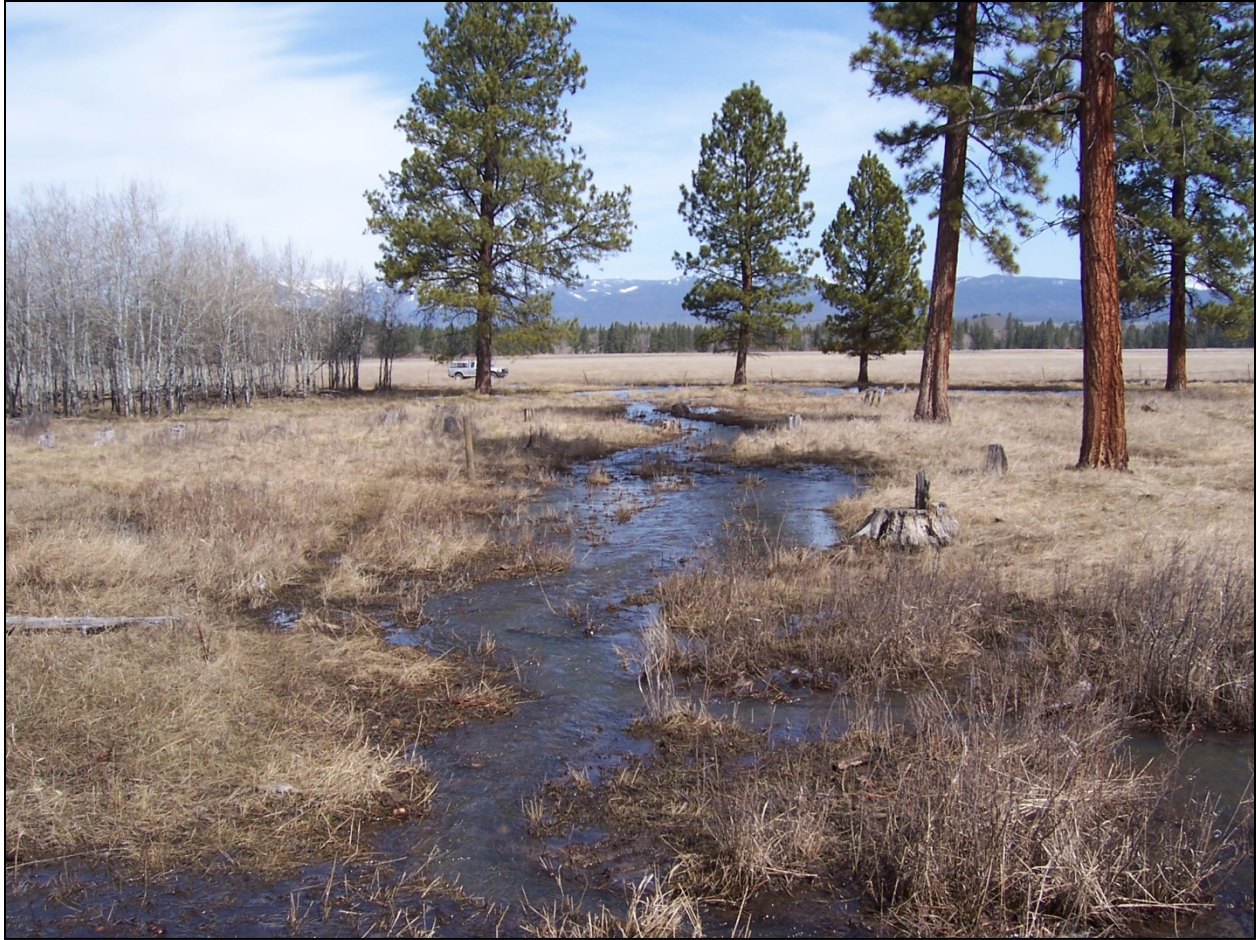
Photo 2: This photo shows water lost from the main (i.e., perched) Pearson Creek channel during the spring runoff period. The new channel will be constructed within this channel, which is likely a segment of the historical channel.

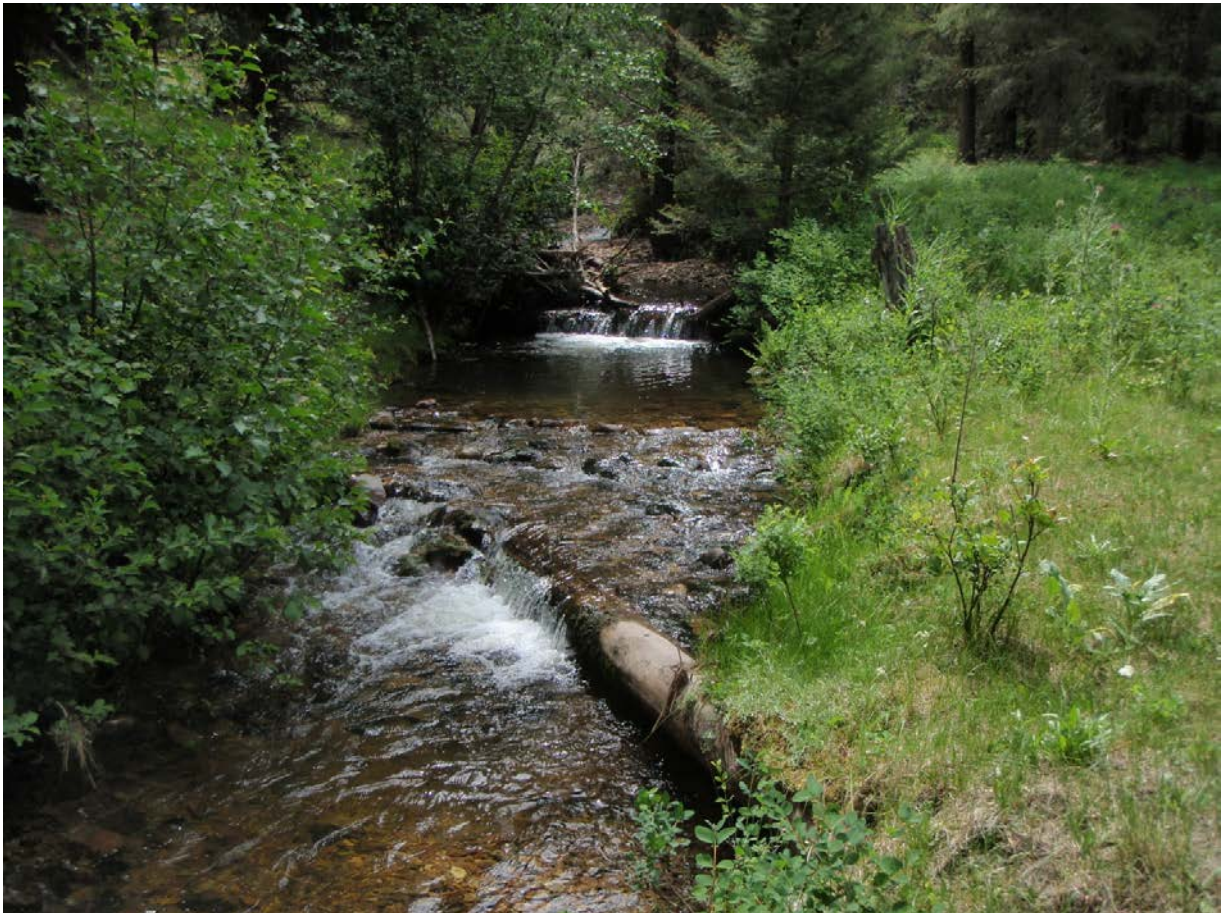
Photo 3. Photo of the upstream reference reach taken in July, 2011. The upper portion of treatment stream will construct a similar channel with step-pool morphology using instream wood features typical of a small forested mountain stream.

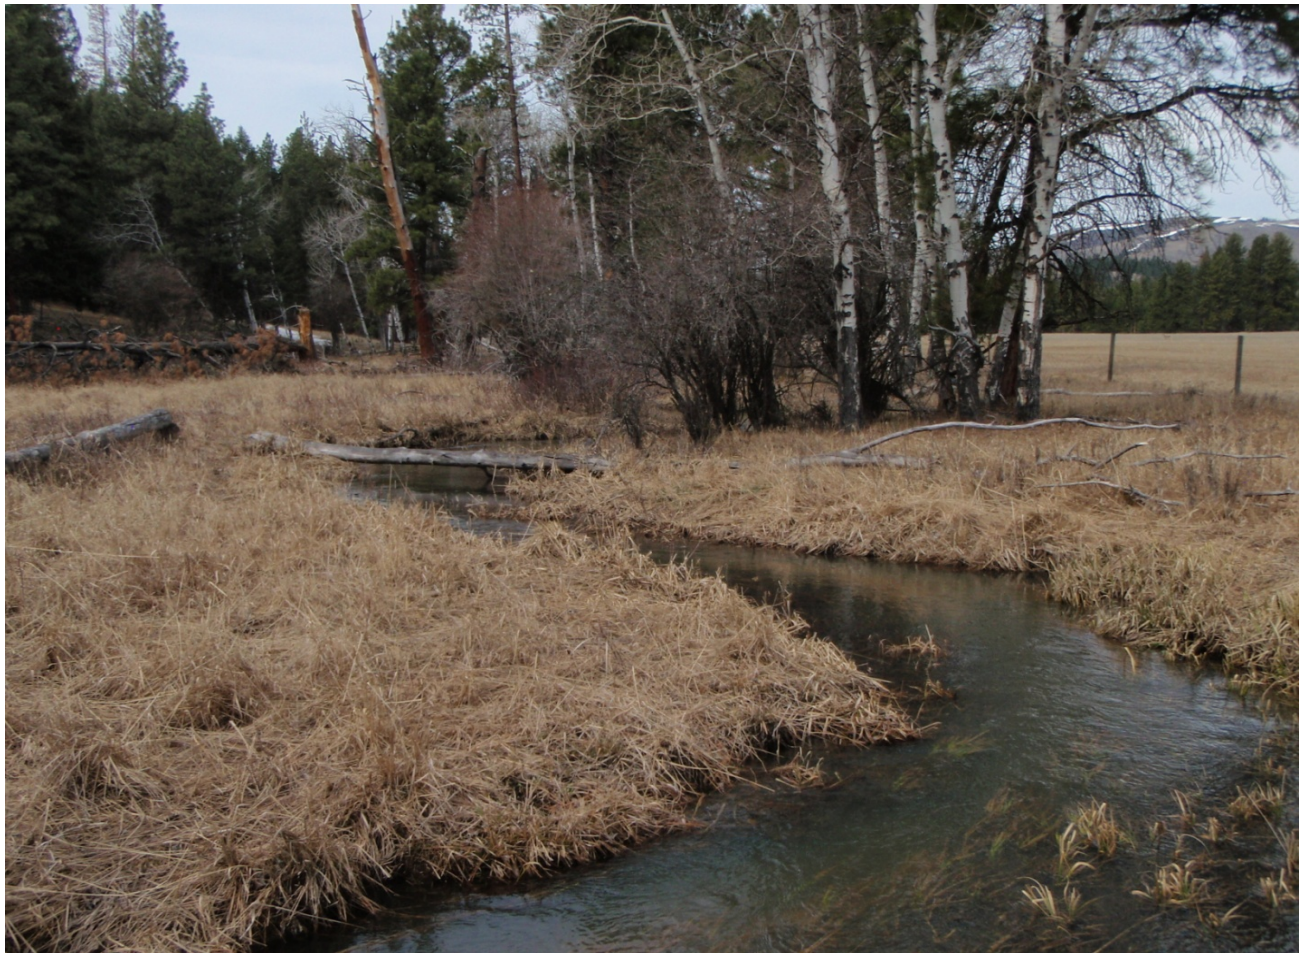
Photo 4. Photo of the downstream reference reach taken in April, 2012. The lower portion of treatment stream will construct a similar meandering morphology using vegetative features typical of a small, low-gradient meadow stream.

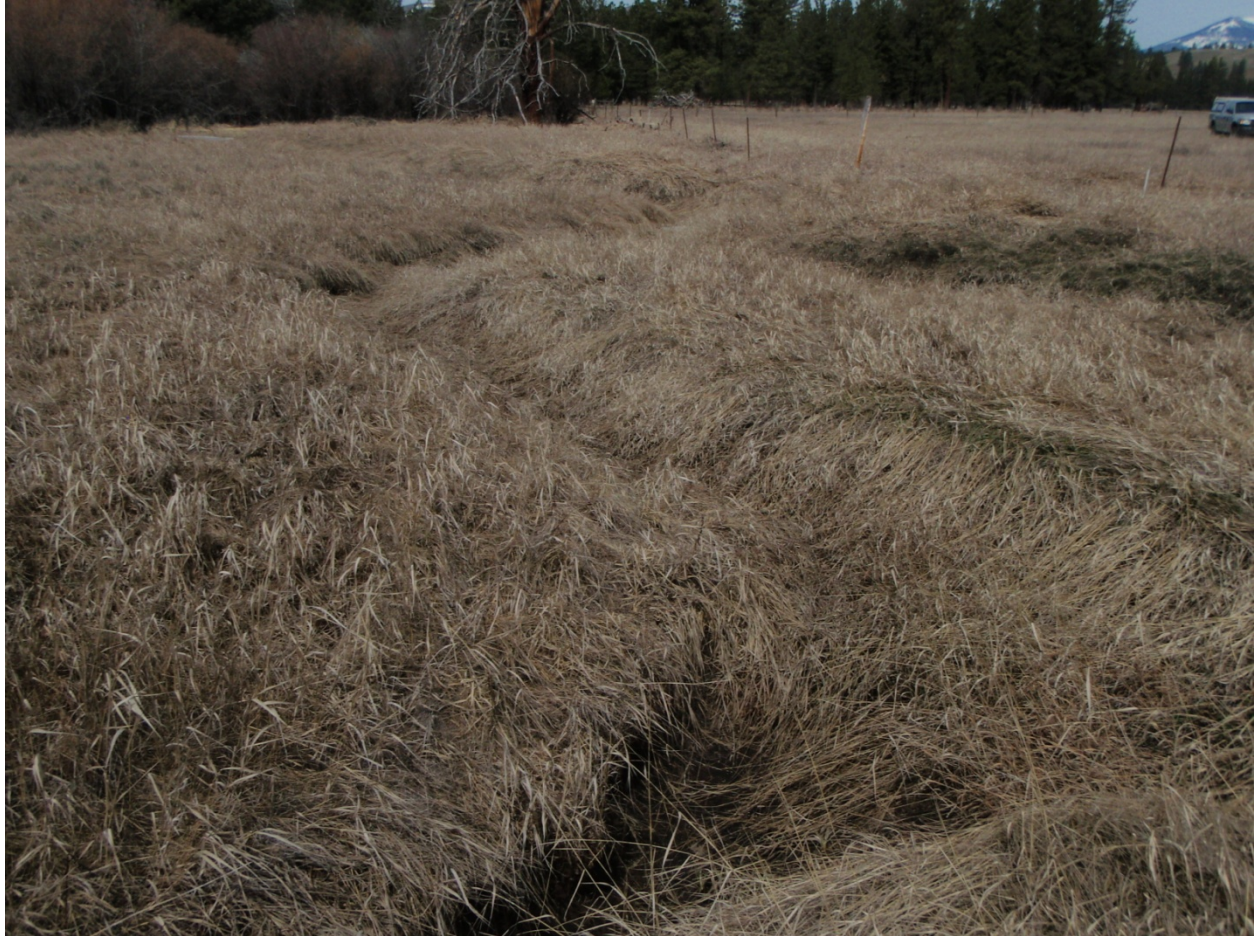
Photo 5: This photo shows a segment of this historical E-type channel just upstream of the county culvert. This segment will be used to the full degree possible.

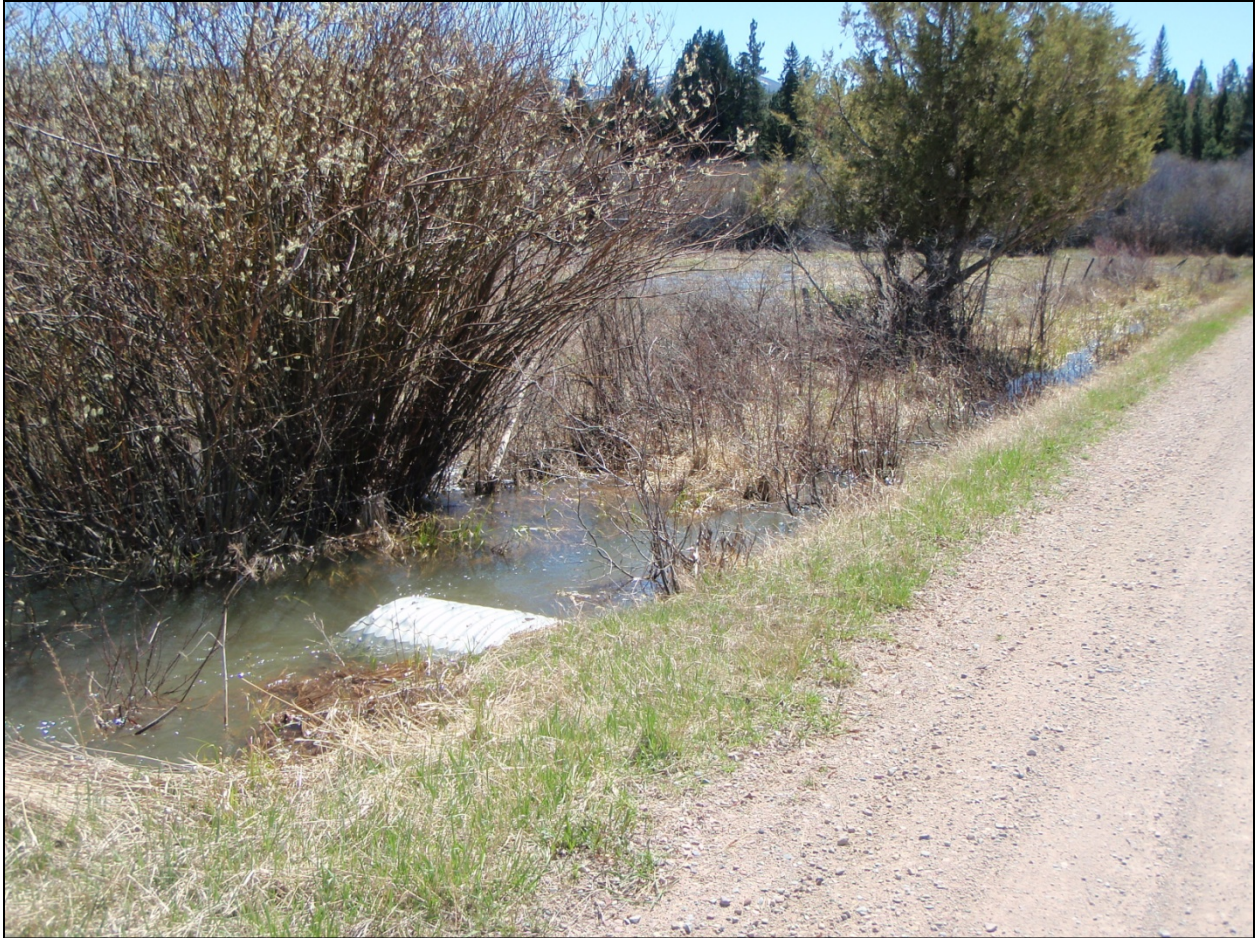
Photo 6: This photo shows the undersized culvert. It also shows water flowing down the borrow pit to the culvert.

Because of the perched location of the channel upstream of the country road, water approaches the culvert crossing from several directions. In addition, the existing 42" x 28" x 30' culvert is impeding fish passage, while also contributes to poor road drainage and flooding of the country road (photo 6). For the road crossing portion of the project, we are working closely with Powell County Road Department to upgrade the culvert to a 7' span x 4' rise x 36' long concrete box culvert. The new box culvert will have a natural stream bottom and accommodate bankfull dimension and discharges up to a 100 year event. At least one additional floodplain culvert is also planned at this site. Refer to *Pearson Creek Culvert Plan & Elevation View* drawing included in the Appendix.
